The following abbreviated history of the Dymocks Building and subject site is taken from the Heritage Branch inventory sheet for Commercial Building "Dymocks" Including Interiors, 424-430 George Street, Sydney (Database No: 2424010):

4.0 PHYSICAL EVIDENCE

4.1 Site Context and Current Condition of Goods Lifts 5 and 6

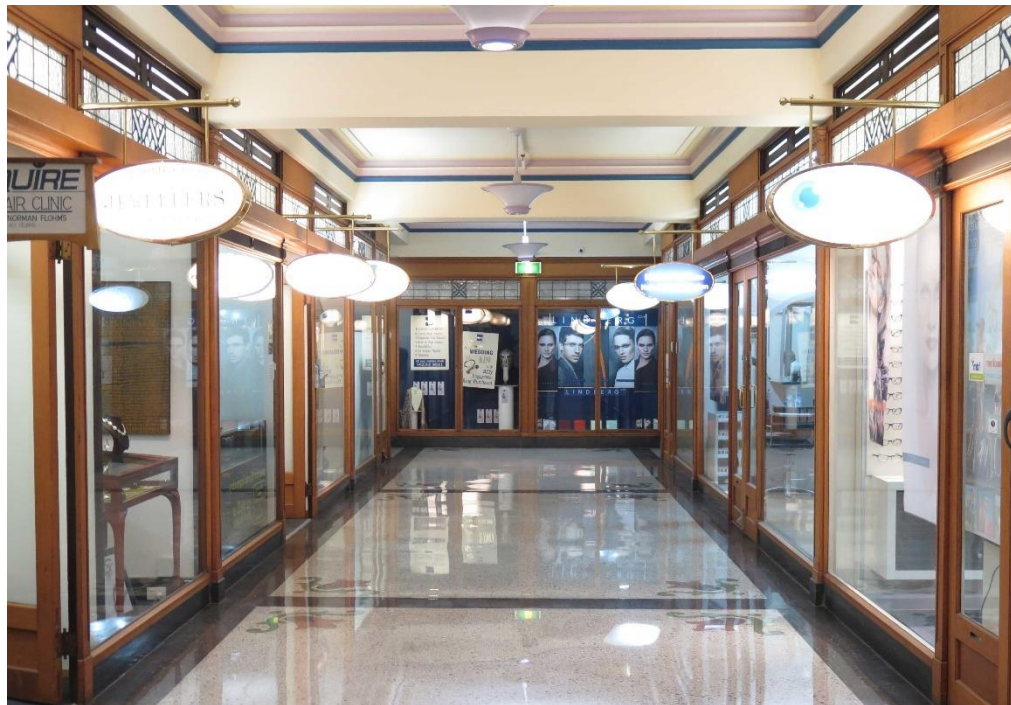
Figure 7 – Fifth Floor, looking east along the retail arcade layout. At the western end is a Showcase that conceals the Goods Lifts and the lavatories. Floors have terrazzo finish throughout (Source: NBRSPARTNERS, October 2015)

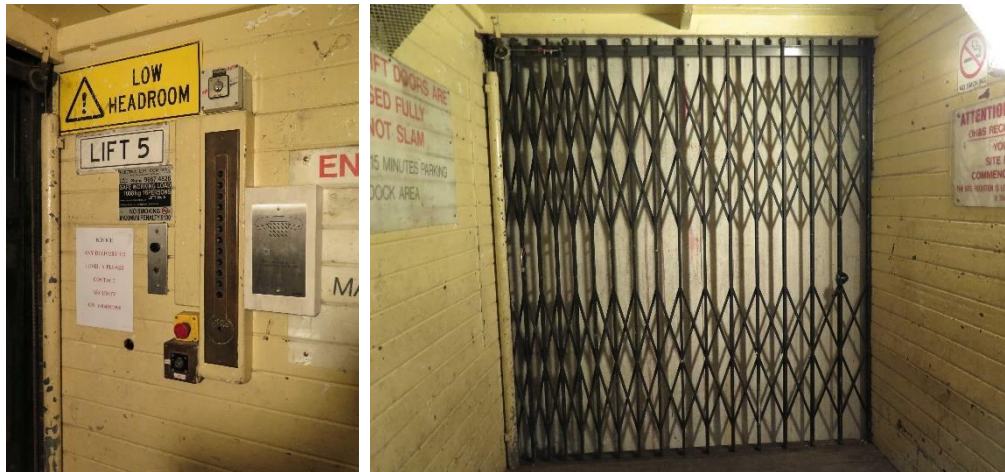
Figure 9 — The interior walls and ceilings of the goods lift car are lined in timber panelling and painted. The original button press panel is located on the wall of each car. The metal horizontally-opening scissor doors are located at the eastern and western door openings. (Source: NBRSPARTNERS, October 2015)

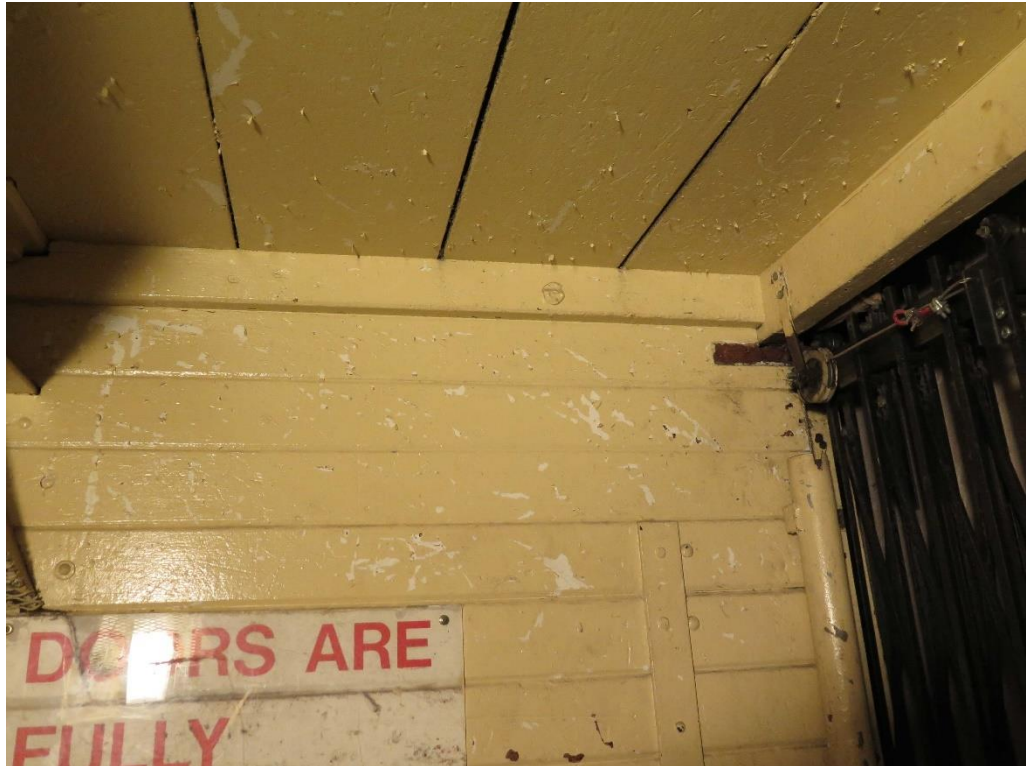
Figure 10 – Detail of the goods lift car showing the junction of the timber panel walls and ceiling and the opening mechanism of the metal scissor doors (Source: NBRS+PARTNERS, October 2015)

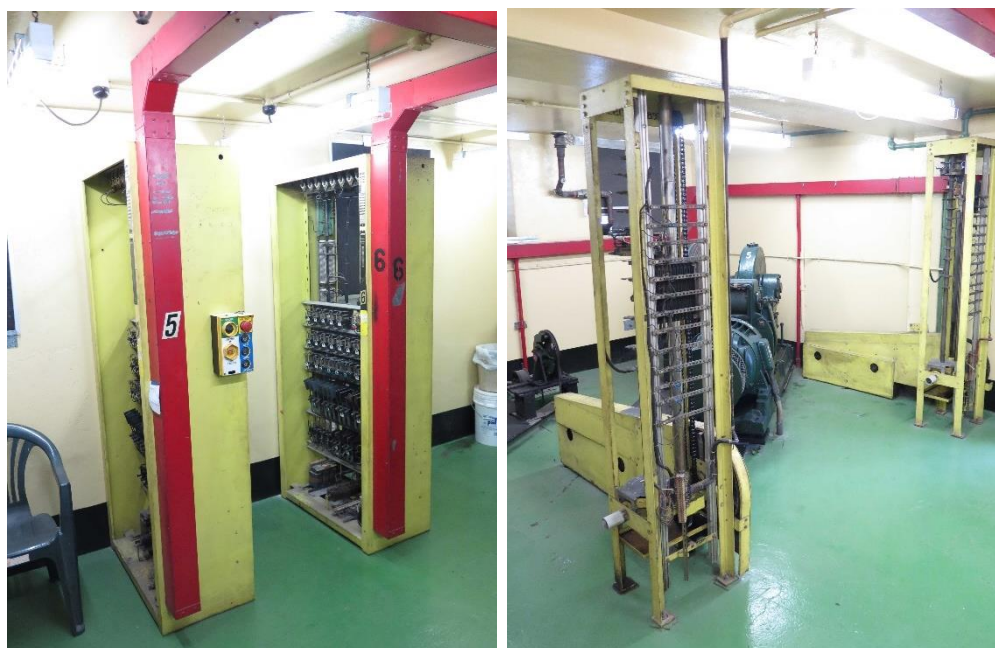
Figure 13 — Roof Level, showing view to Otis goods lift equipment including winches and switches in the Motor Room (Source: NBRS+PARTNERS, October 2015)

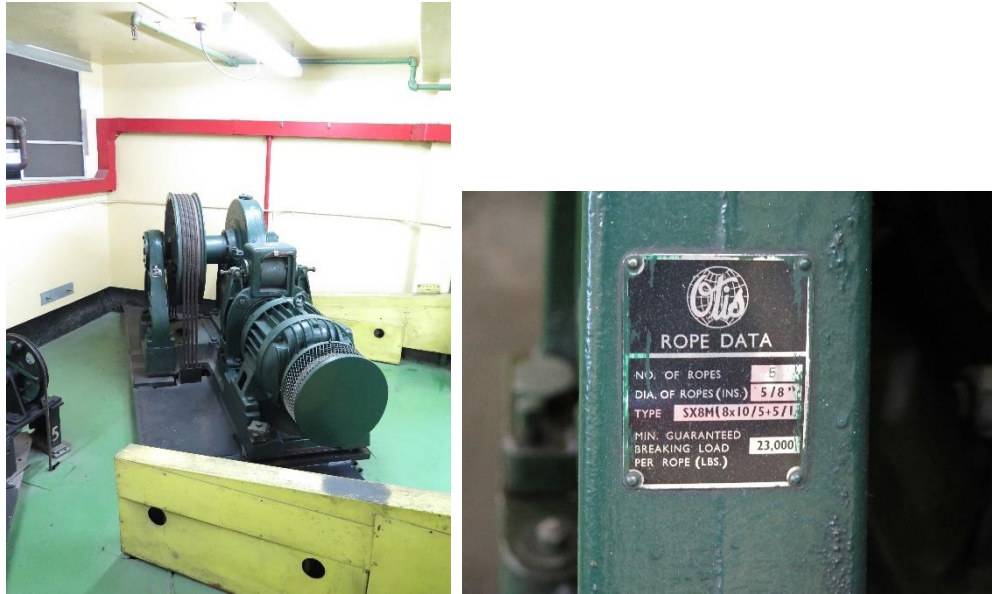
Figure 14 – Roof Level, showing view to Otis goods lift equipment, including winches and switches, in the Motor Room (Source: NBRS+PARTNERS, October 2015)

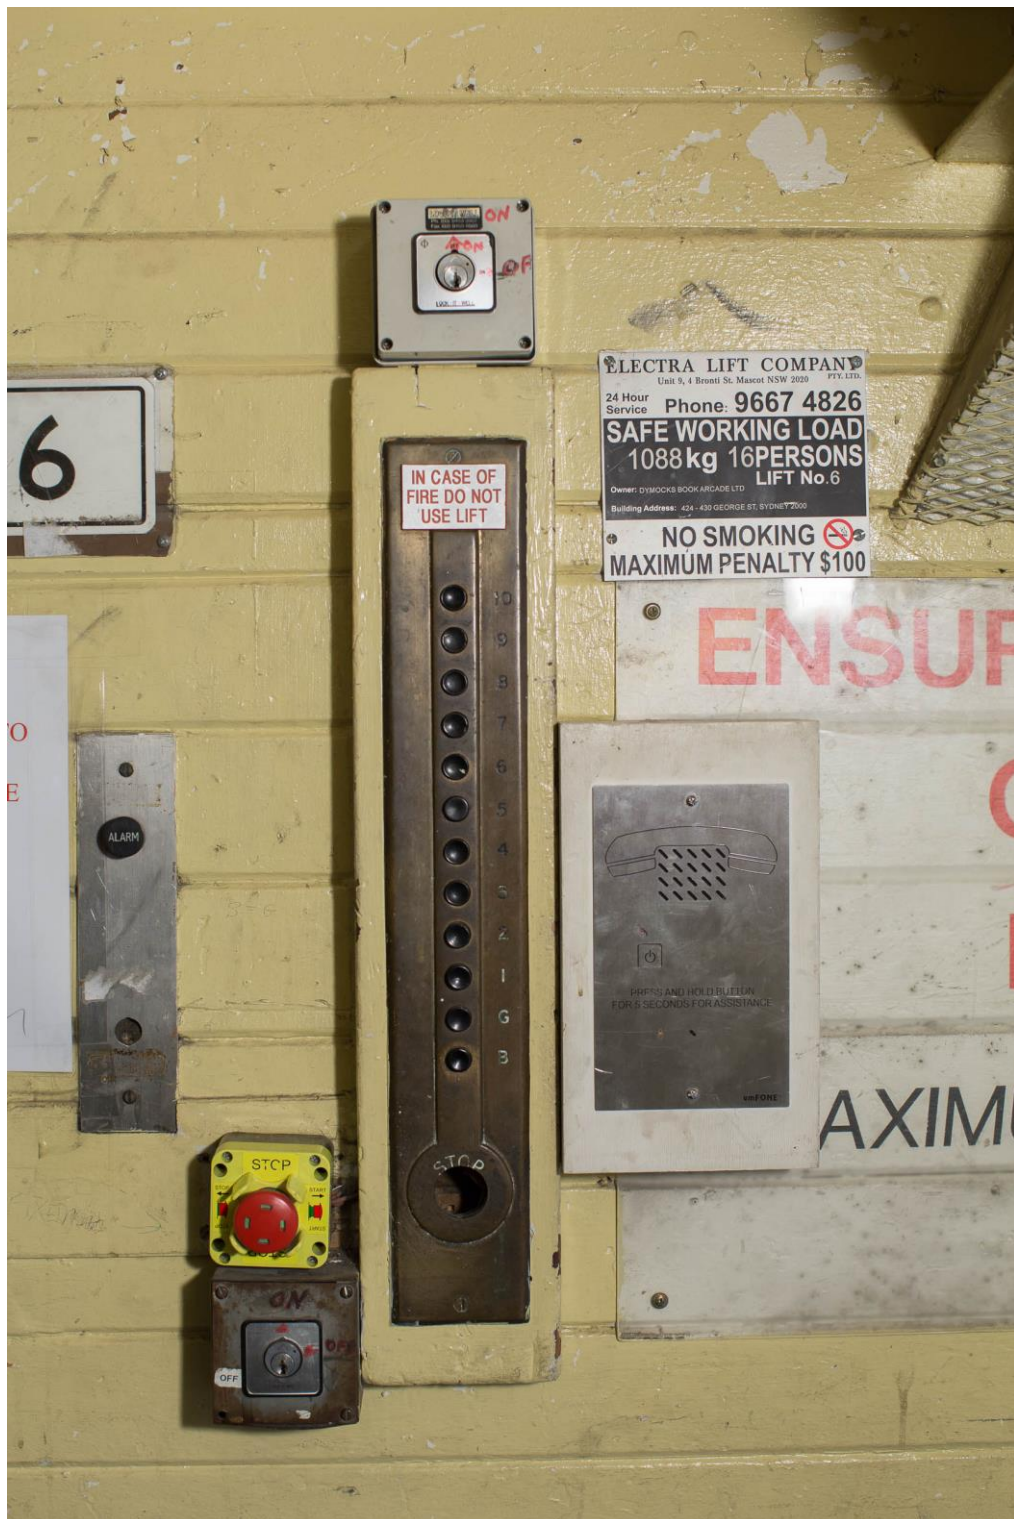
Figure 19 – Dymocks Building, Goods Lift, Interior of Car – showing the indicator panel and button press (Source: Alexander Mayes Photography, 2016)

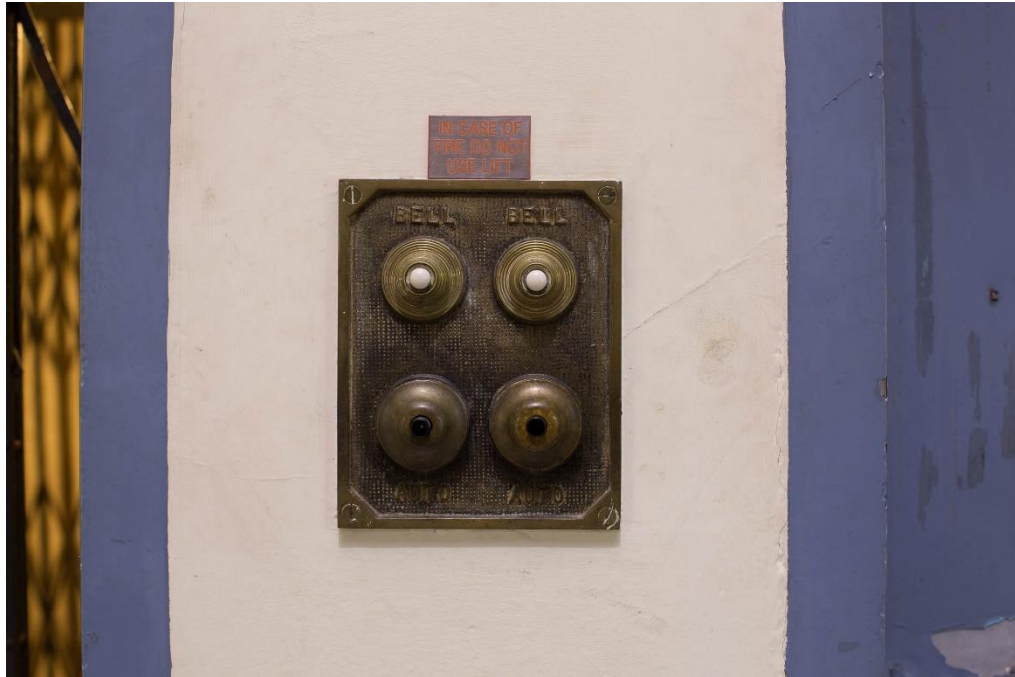
Figure 20 – Dymocks Building, Goods Lift, Wall Between Goods Lift Cars showing brass indicator panel and button press (Source: Alexander Mayes Photography, 2016)
